Mars Litter Inventory: Using HiRISE to Find our Stuff.

Tim Parker
Rob Manning
February 28, 2007

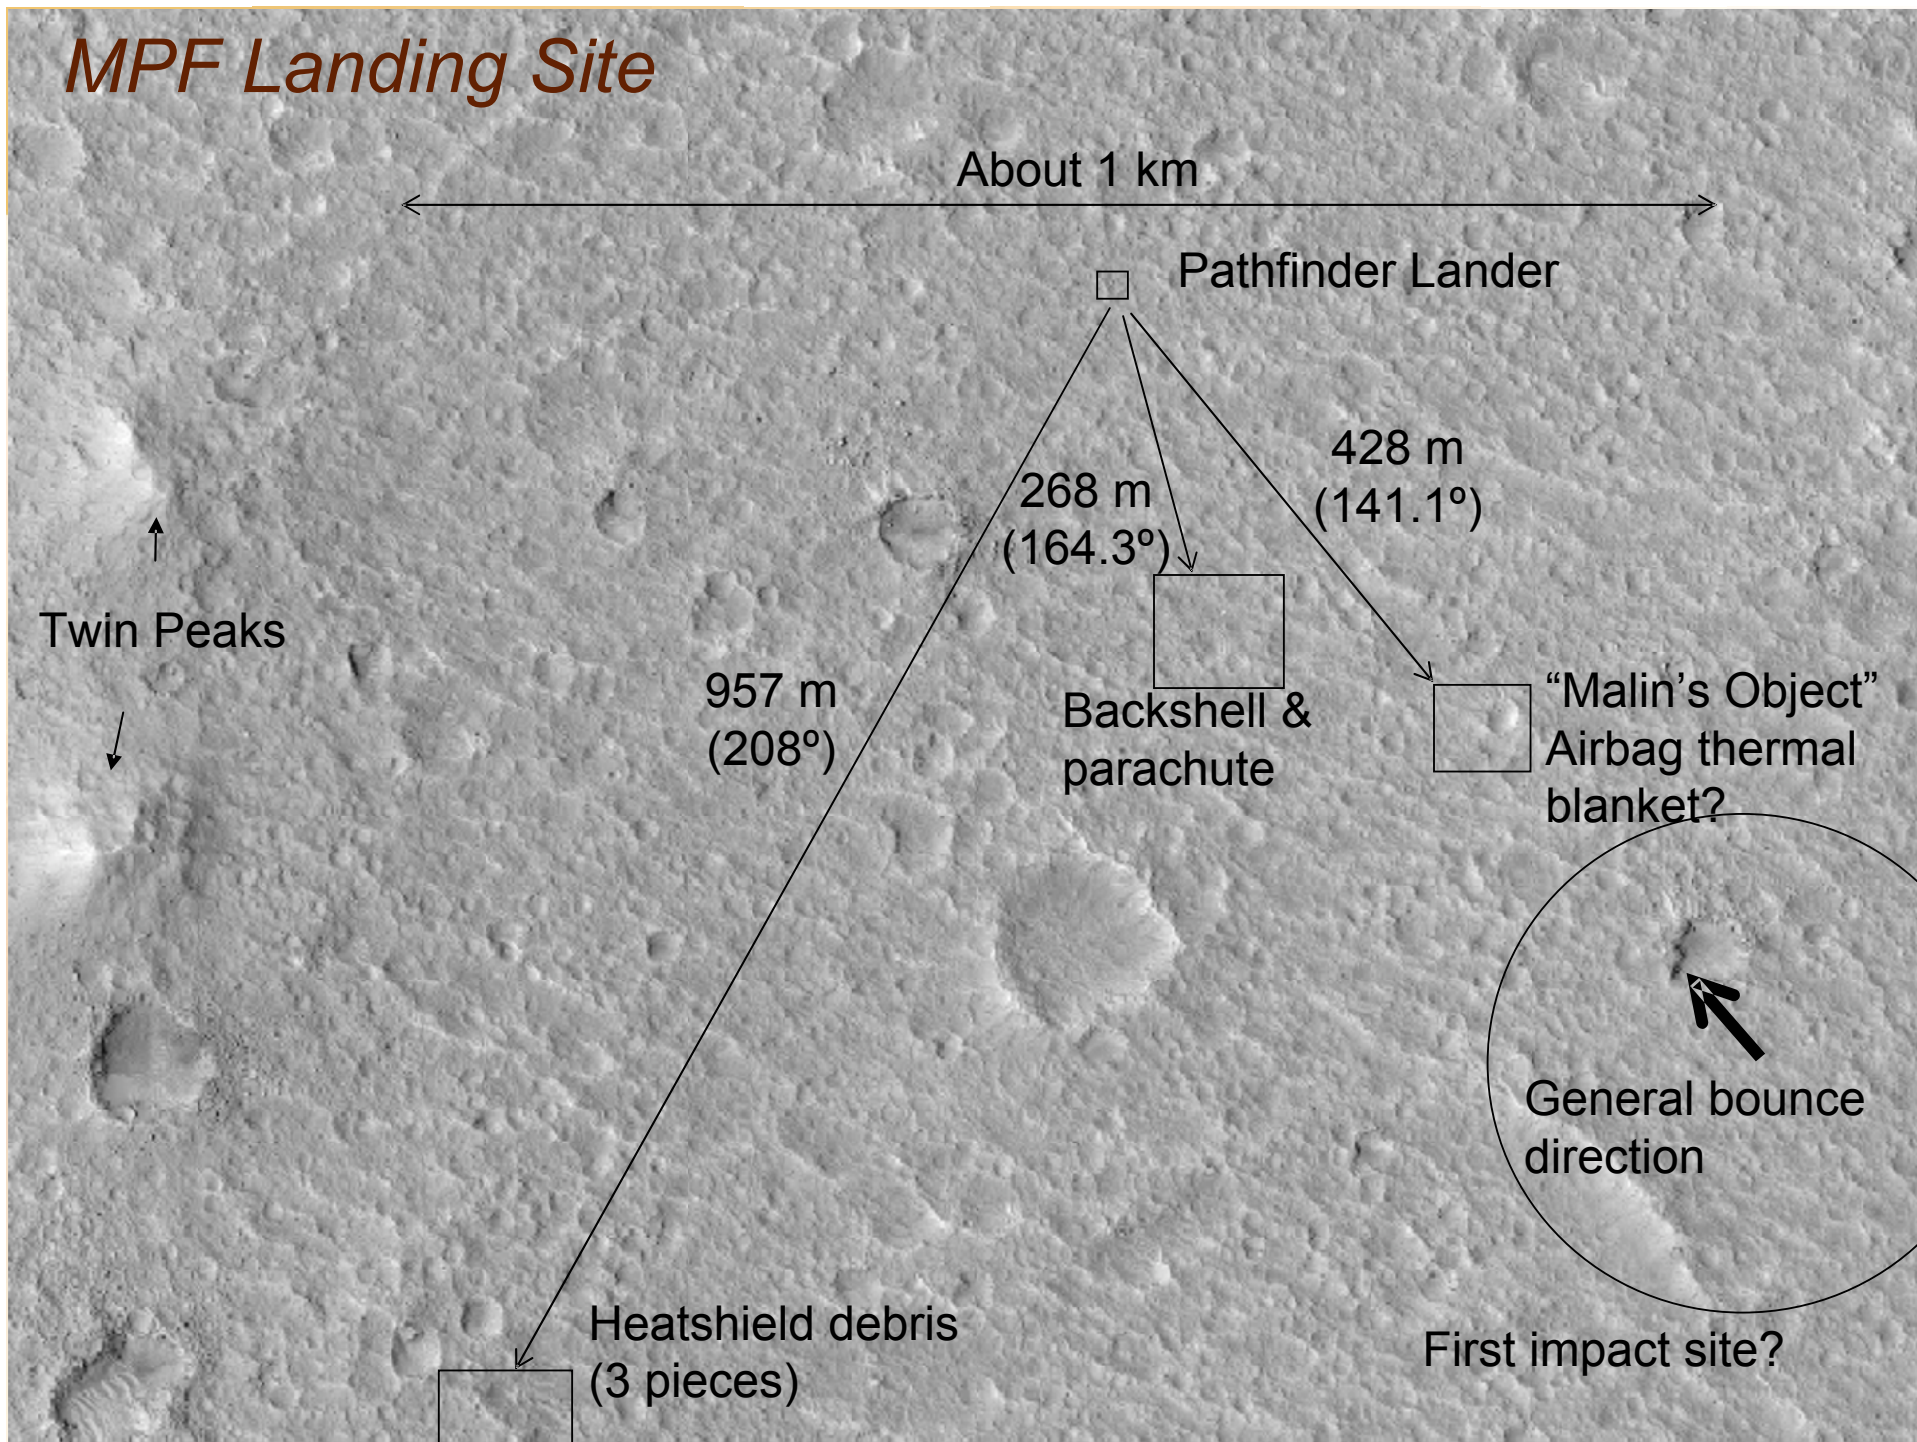
MPF Landing Site

About 1 km

Pathfinder Lander

268 m
(164.3°)

428 m
(141.1°)

Twin Peaks

957 m
(208°)

Backshell &
parachute

"Malin's Object"
Airbag thermal
blanket?

General bounce
direction

Heatshield debris
(3 pieces)

First impact site?

- *Positions of MPF's hardware are consistent with post-MPF trajectory reconstruction.*
 - *Per trajectory reconstruction in 1997, MPF arrived from the northeast (retrograde entry) - residual velocity and higher ballistic coefficient would have resulted in the heatshield landing around 1 km to the southwest of the first lander impact site.*

- *Heatshield debris is about 0.9 km to the SE of the (presumed) airbag blanket*
 - *Per trajectory reconstruction in 1997, the best estimate of MPF first impact point was SE of the final MPF site. Rough estimates of acceleration during bouncing by Sam Thurman suggested NW initial direction and about 800 m of bouncing. (MPF did not have an IMU that could be integrated to gage position).*

- *If the "Malin Object" (428 m from the lander) is indeed an airbag blanket and it came off in the early bounces, then the estimate of 1 km is long by a factor of 2, but it is in the correct direction. However the blanket may have come off half way during the bouncing. (bounced >15 times, for > 1 min)*

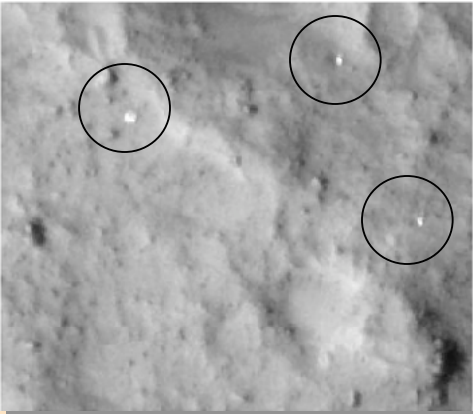
MPF

Heatshields as seen by HiRISE

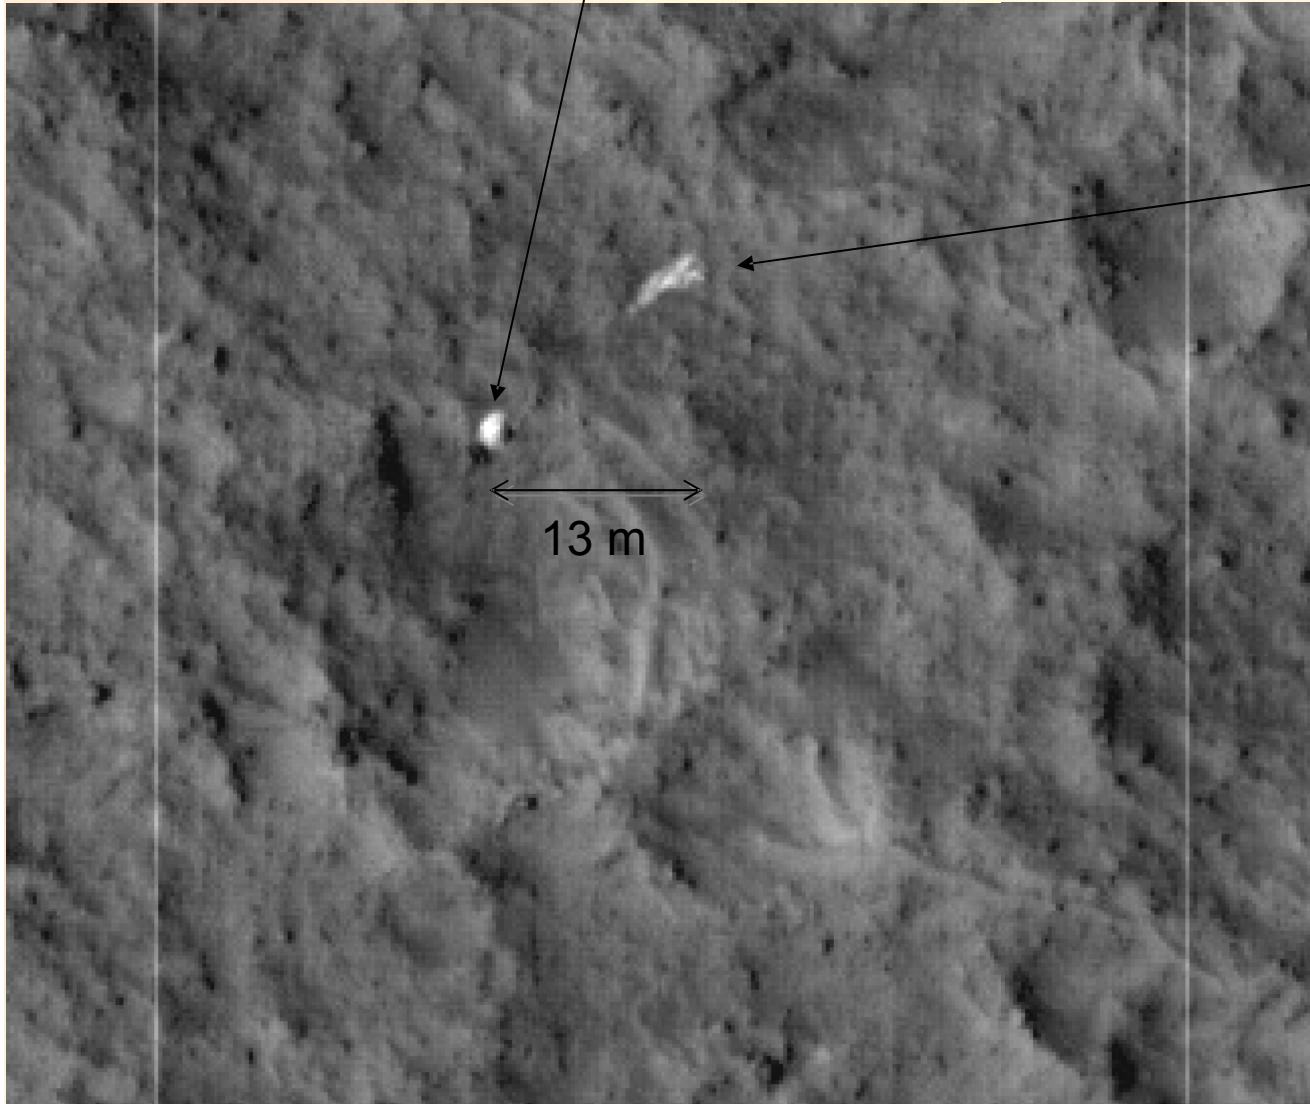
MPF's Backshell and Parachute

Backshell with parachute canister up.
(about 2.1 m in diameter - very close to true size)

Parachute & suspension lines lies fully stretched out, apparently undamaged, on the ground.

Orientation is consistent with an arc trajectory from the North East (parachute trails backshell).

- *Future color HiRISE image will help.*
 - *Parachute and backshell appear nominal (very similar to MER's)*
- *No indication that MPF had any anomalies during EDL.*

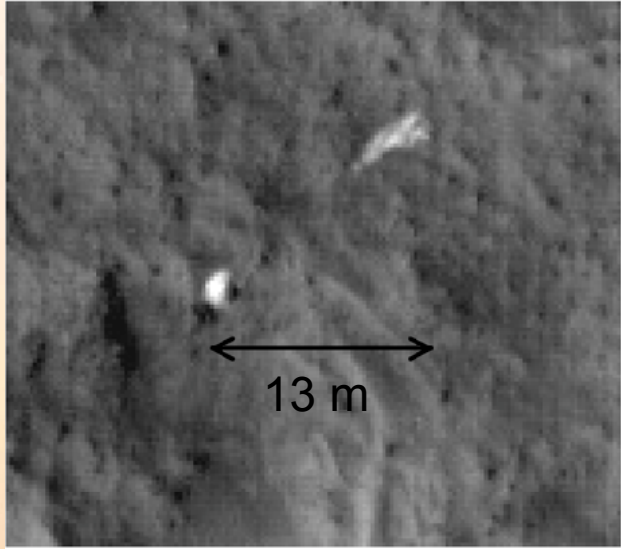
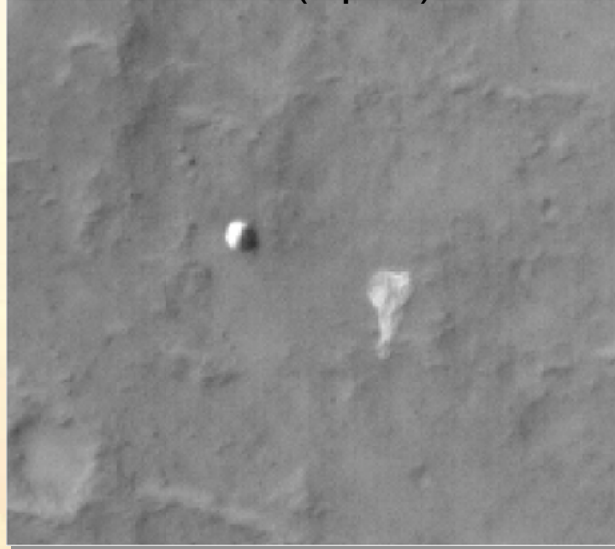
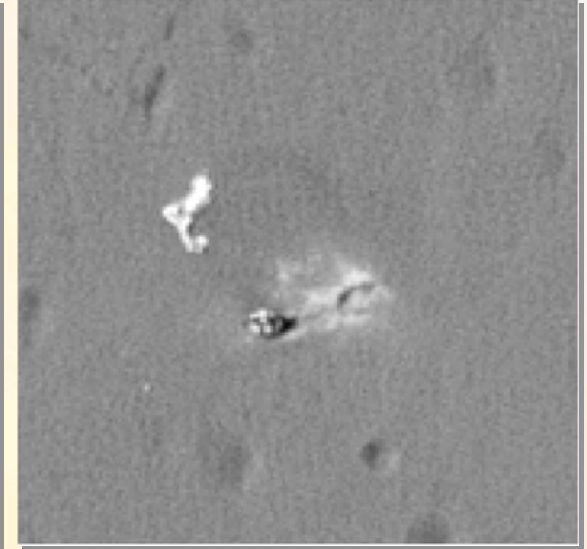
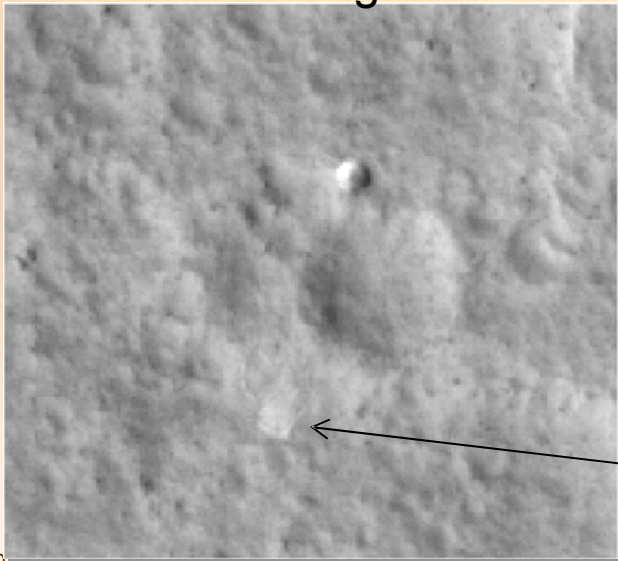
Backshell's & Parachutes as seen by HiRISE

All but MER-B's backshell appear cone-pointed up.

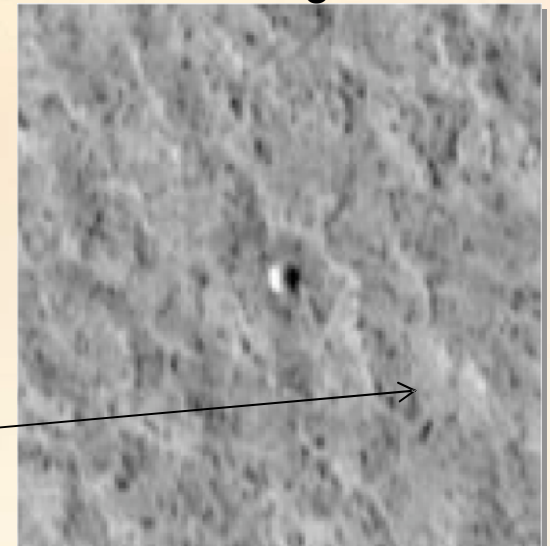
Viking 2

VL-2's parachute is not clearly visible.

Dusty parachute

Is this it covered with dust?

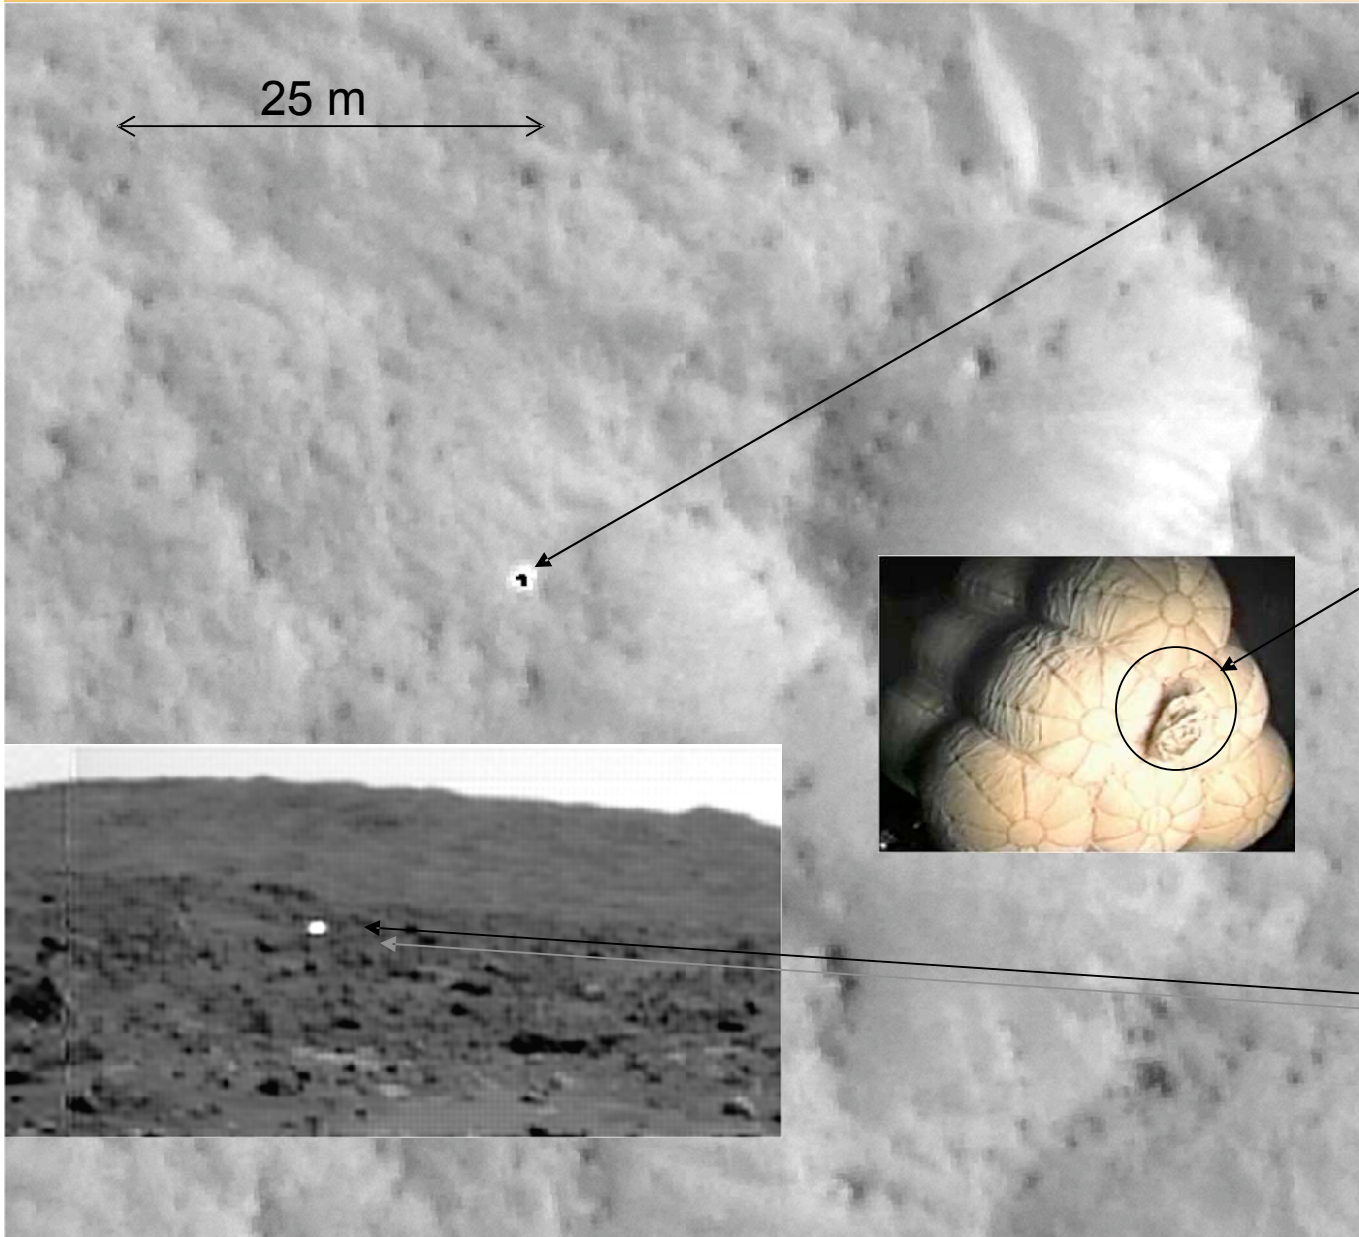
“Malin’s Object”: MPF Airbag Blanket?

Object is about 1.1 m in diameter.

This is probably one of the four airbag “covers / thermal blankets” (each about 1.1 m in dia). The inside of this blanket was covered with highly reflective aluminized mylar.

It probably came off in one of the first stressful impacts and may be near the first impact location.

Same very bright object as seen in super-res image taken by MPF’s IMP camera (428 m away).

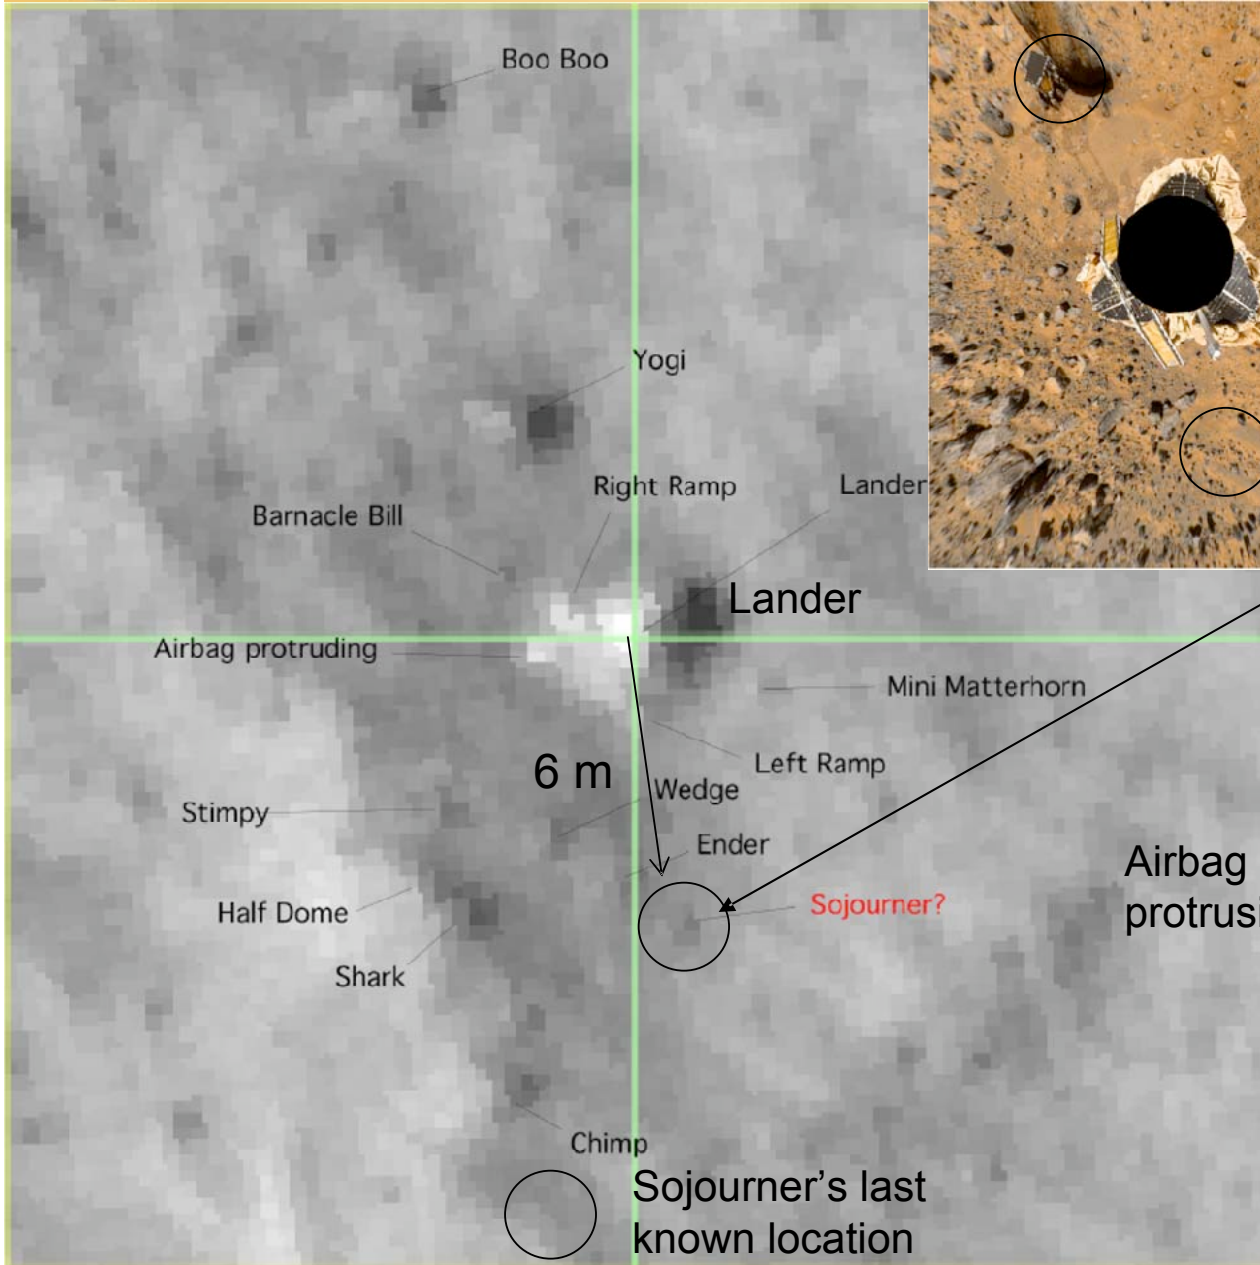
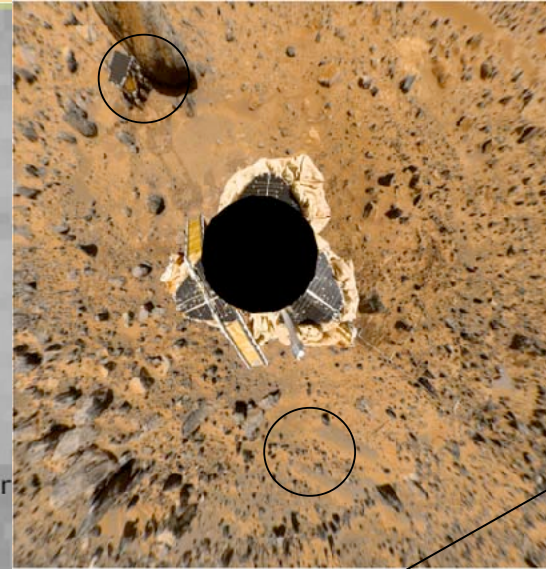
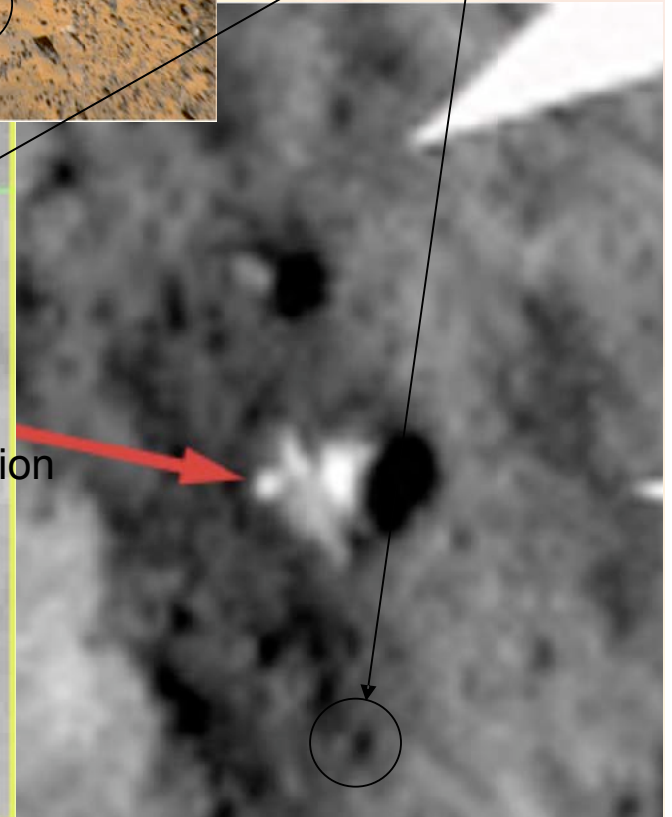
MPF Lander (& Sojourner?)

Is this Sojourner?

A color HiRISE image may confirm.

Airbag protrusion

- *Lander's airbags, ramps are clearly visible in the HiRISE image, however Sojourner is not so clearly visible. Why?*
 - *Dust on rover? However MPF parachute and airbag cover are still bright.*

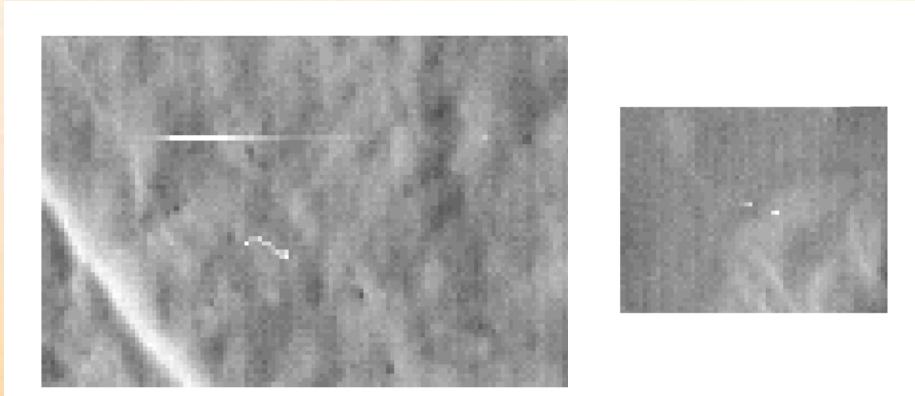
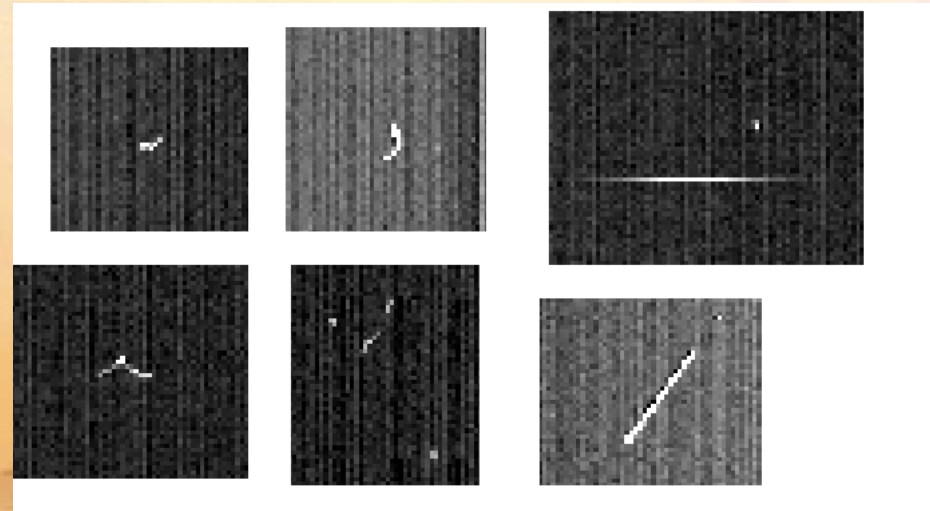
*Who'da thunk that cosmic ray hits on CCDs might look like "stuff"?

< Cosmic ray hits on Beagle 2 search image

Cosmic ray hits on star >
calibration images
(without Mars background)
